West of Wales SMP2. Review of Coastal Processes and Geomorphology

Appendix C
Coastal Processes

HASKONING UK LTD.
COASTAL & RIVERS

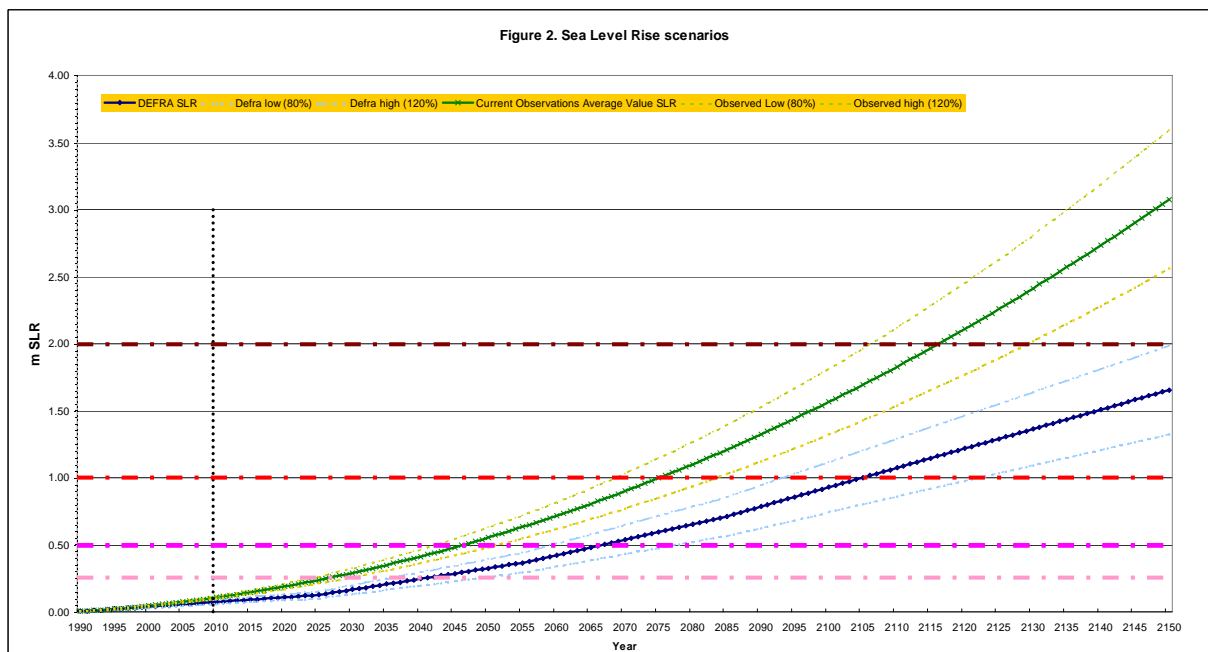
Two baseline scenarios have been considered and the sensitivity, in terms of time, has been examined. Figure 2 shows a graph of the Defra Guidance values for sea level rise together with the UKCP09 H++ scenario. These scenarios are referred to within the SMP2 document as the 1m SLR scenario (with a 1m projected sea level rise over a nominal 100 years) and the 2m SLR scenario (with a 2m projected sea level rise over a nominal 100 years). The graph also shows an 80% and 120% banding of values, this has been used as a sensitivity in assessing erosion rates discussed later. The graph is projected forward over 150 years.

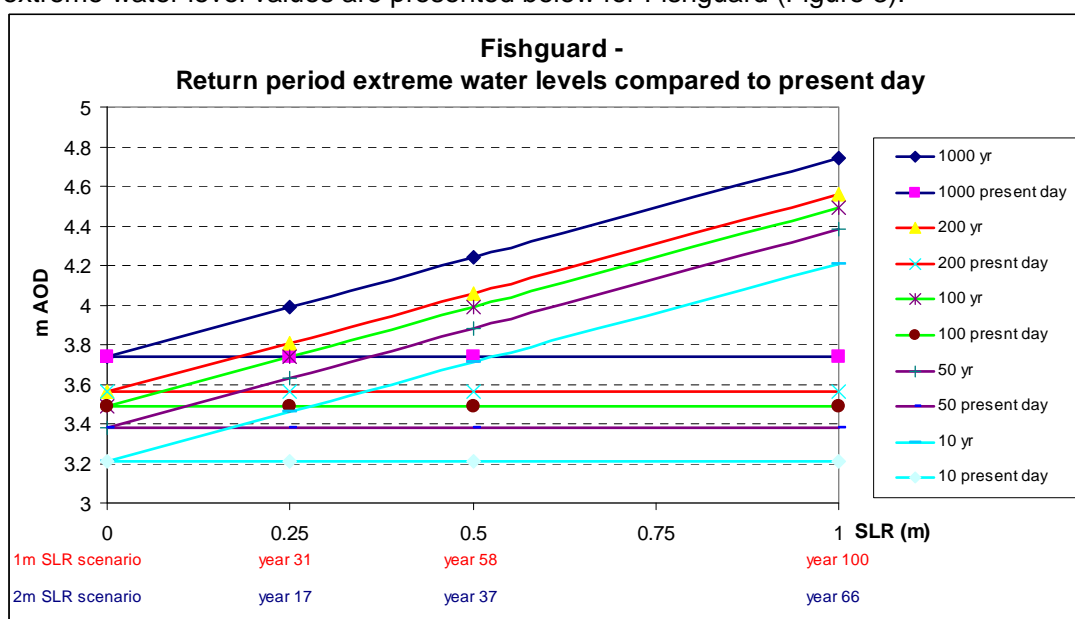
Figure 3 Change in return period of extreme water levels for Fishguard.

A key impact of sea level rise would on the frequency of specific water levels. Typical extreme water level values are presented below for Fishguard (Figure 3).

It may be seen that a 1:1000 year return period water level (present day) might occur with a return period of 1:10 years in 60 years time, under a 1m SLR scenario, and in 40 years time, under a 2m SLR scenario. Potentially more significant is that with sea level rise, normal tidal levels (MHWS) would reach that expected during extreme events. This is illustrated in Figure 4, showing a comparison in years between MHWS and the 1:10 yr. extreme water level for the two baseline SLR scenarios.

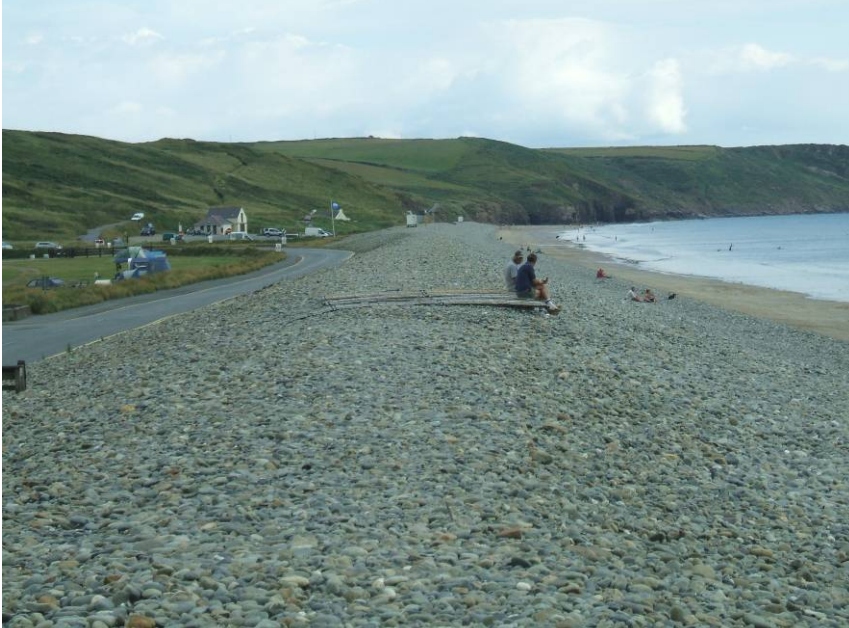
<p>Picture: Newgale barrier beach</p>

<p>Description</p>	<p>This unit is situated at the tip of the Pembrokeshire Peninsula and encompasses St Bride's Bay. The bay is bounded by (1) the southerly hard rock coast between Wooltack Point and Little Haven, (2) the easterly frontage between Little Haven and Newgale, which is characterised by beaches held between rocky headlands, and (3) the northerly hard rock coast between Newgale and Ramsey Island. The frontage includes the settlements of Little Haven, Broad Haven, Nolton Haven, Newgale, and Solva.</p>
<p>Geology and Physical Controls</p>	<p>The volcanic rock of Wooltack Point is followed by sandstone, which is present to the north of Newgale, although an igneous intrusion forms the cliffs west of Little Haven. The south facing coast to St David's Head is predominately mudstone.</p> <p>The northern and southern boundaries effectively form massive headlands that limit the wave climate within the bay and prevent sediment exchange with neighbouring units. There are also numerous headlands of smaller scale that have strong local effects.</p> <p>Ramsey Island provides protection to the northern boundary of the unit.</p>

<p>Geomorphology</p>	<p>The geomorphology of this large unit is quite varied. Most of the coastline is comprised of hard rock cliffs, fronted by steep shore platforms. Although eroding they are highly resistant and so retreat very slowly, producing little sediment.</p> <p>The next most dominant features of the bay are the long sandy beaches fringing the eastern boundary. The largest of these is</p>

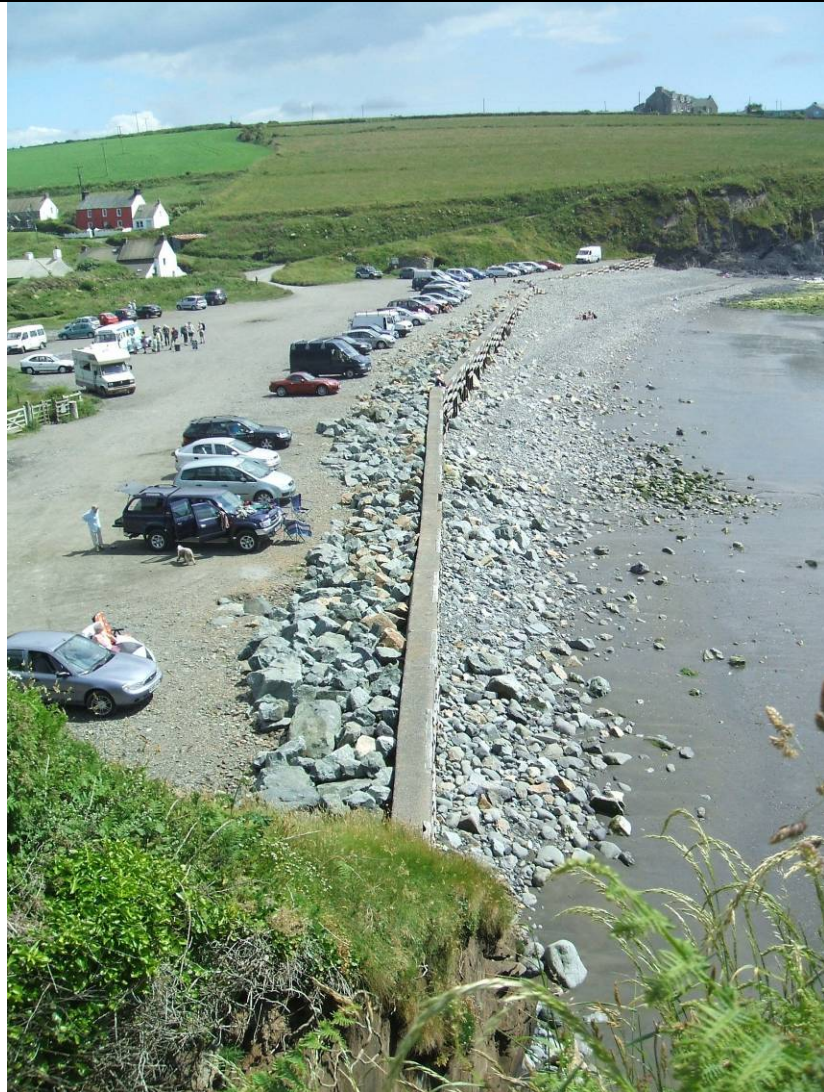
Picture:
Abereiddy beach
and seawall

Description	This unit is situated at the southern most limit of Cardigan Bay. It extends east and north from St David's Head to Strumble Head and is largely undeveloped, although there are two small villages, Porthgain, which has a harbour, and Abercastle. There are also cottages close to the beach at Abereidid.
--------------------	---

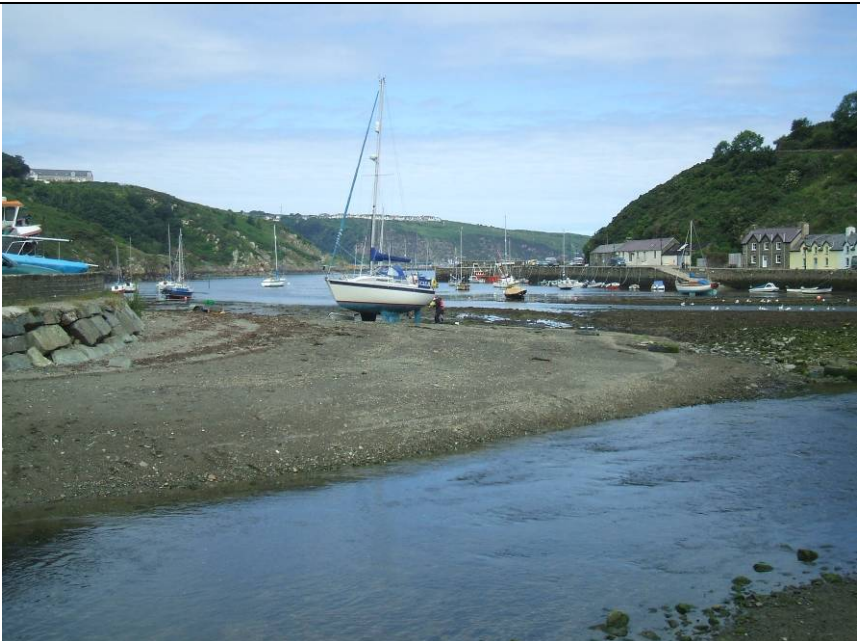
<p>Picture: Lower Town harbour</p>

<p>The Lower Town harbour is situated in the recessed rocky mouth of the river Gwaun. It is a natural harbour that benefits, in addition, from the protection of the north breakwater. As a result finer sediments have accumulated within it. These are backed by coarser gravels and artificial defences.</p> <p>Between the mouth of the Afon Gwaun and Pwllgwaelod the shore is again composed of hard rock cliffs with small coves, some of which contain beach deposits.</p> <p>At Pwllgwaelod is a bay with low sand foreshore and steeper upper storm beach with an outwash channel from Cwmyr Eglwys. This bay is slowly eroding. The remainder of the unit to Dinas Head is comprised of hard rock cliffs.</p>
Wave Climate	Wave conditions have not been quantified within this unit. It is quite protected, because it faces north across the Irish Sea, rather than towards the Atlantic. The Fishguard breakwaters provide significant additional protection within Fishguard Bay.

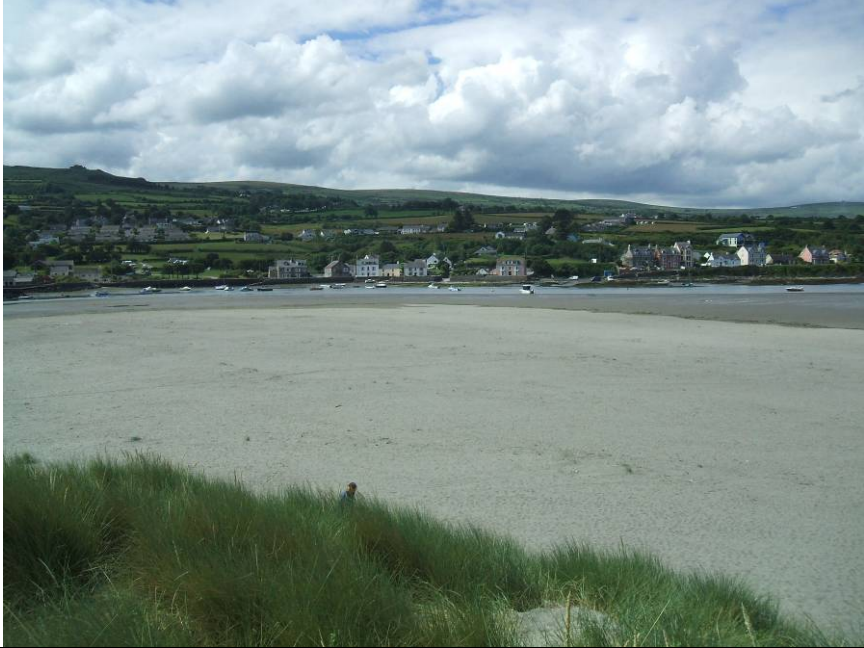
<p>Picture: Parrog and The Bennet</p>

<p>Newport Sands is the estuary of the river Nyfer. This was once a ria, but has infilled with sand. A substantial duned sand ridge (the Bennet) has developed from the northern side, which pushes the channel towards the south. Rocky margins can still be seen at Parrog and on both sides of the estuary behind the bar. At Parrog the rock continues above the platform area but is then overlain with a well vegetated clay slope around three metres high. Occasional scour has led to the placement of rock.</p> <p>Between Newport Sands and Cemaes Head the shore returns to the hard rock cliffs typical of this unit. This is interrupted at Ceibwr Bay by a shingle beach backed by scrub.</p>
Wave Climate	<p>Wave conditions have not been quantified within this unit. It is quite protected, because it faces north across the Irish Sea, rather than towards the Atlantic. The original SMP indicates that the predominant wave direction is from the west-northwest.</p>

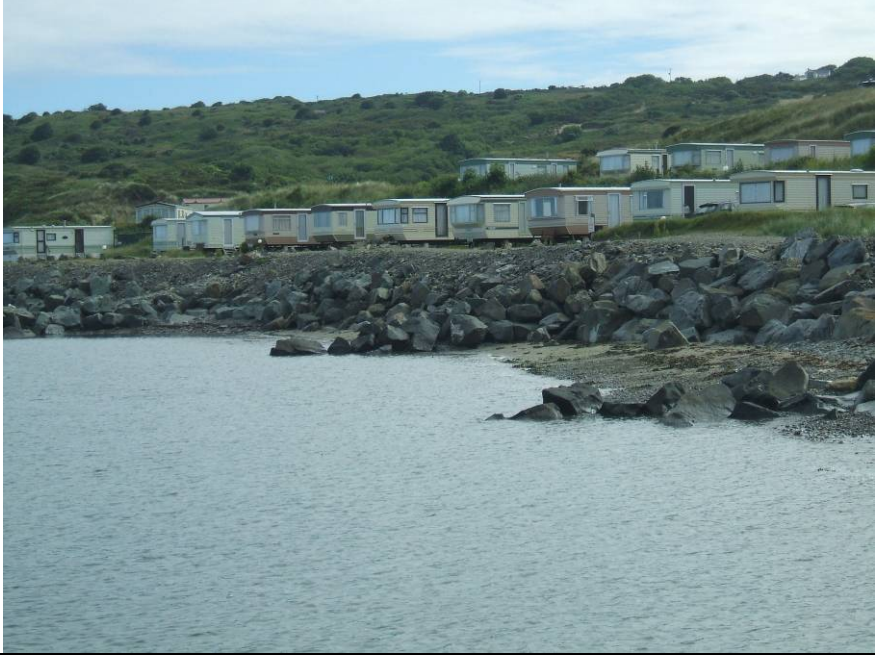
<p>Picture: <i>defences on the north side of Gwbert Spit</i></p>

<p>Description</p>	<p>This unit extends from Cemaes Head across the Teifi estuary, east to Aberporth bay, and then east northeast to New Quay head. The Teifi estuary and the spit features at its mouth are described in Section 5 of the Estuaries Assessment. The coast is mainly undeveloped, except around Aberporth.</p>
<p>Geology and Physical Controls</p>	<p>Cemaes Head, the headland of Carreg Lydan and Cardigan Island, protect the Teifi estuary. Elsewhere headlands provide local protection. Notable examples include: Foel y Mwnt which retains the Mwnt beach, Pencribach, and the other headlands along the Aberporth frontage, and Ynys-Lochtyn. The sheltering effects of Pencribach can be seen to Tresaith</p> <p>The outcrops of rock seen between Craig-y-Gwbert and Traeth-y-Mwnt belong to the Gwbert formation. The rocks comprise alternating bands of mudstone and thin sandstone. There are patches of eroding boulder clay. From Mwnt to Ynys-Lochtyn the rocks are mainly shales of the Ordovician period. The dominant lithology of the Mwnt formation is a grey banded mudstone, and thin cross laminated sandstone. Mwnt, and the area around it, is overlain by boulder clay.</p> <p>The Tresaith formation is well exposed in the cliffs at Penbryn Beach where it comprises a series of mottled green and grey mudstones with black shales. These pass laterally into a thick sequence of banded mudstones, with thin silty and sandy laminae, which are exposed in the cliffs at Aberporth and Cribach Bay. The Tresaith formation grades into the overlying Llangrannog formation through the gradual introduction of thin sandstone laminae and lenses</p>

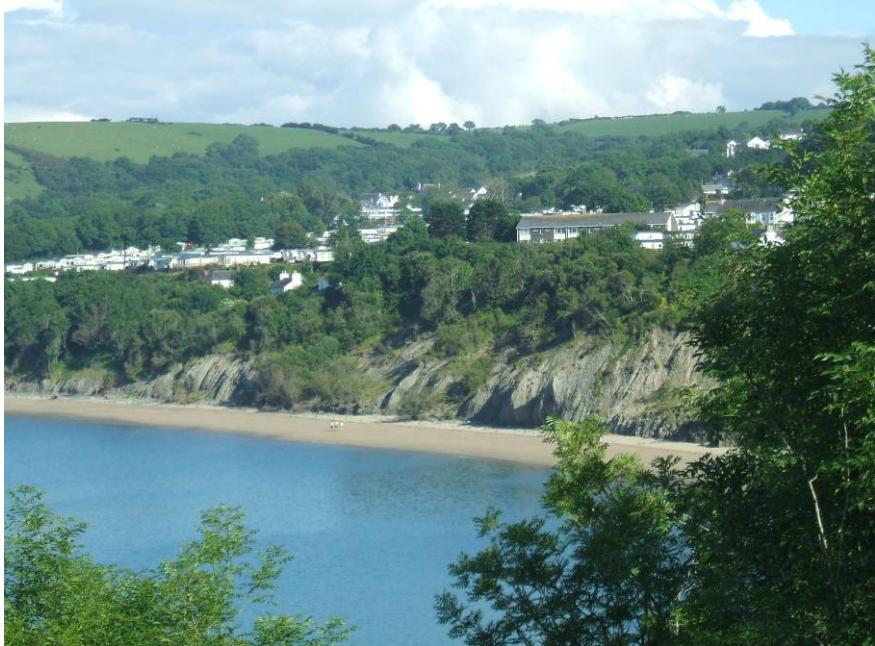
<p>Picture: Boulder Clay cliffs along New Quay Bay</p>

<p>Geomorphology</p>	<p>The shoreline is comprised of a series of vegetated sea cliffs and coastal slopes. A sand and gravel beach fronts much of the cliff line, except immediately south of New Quay Harbour, where a boulder covered rock platform is exposed.</p> <p>The predominantly soft erodible clay cliffs have allowed the coast to develop to a bay shape, controlled principally by the sheltering given by New Quay Head. The underlying bay shape is distorted by the</p>

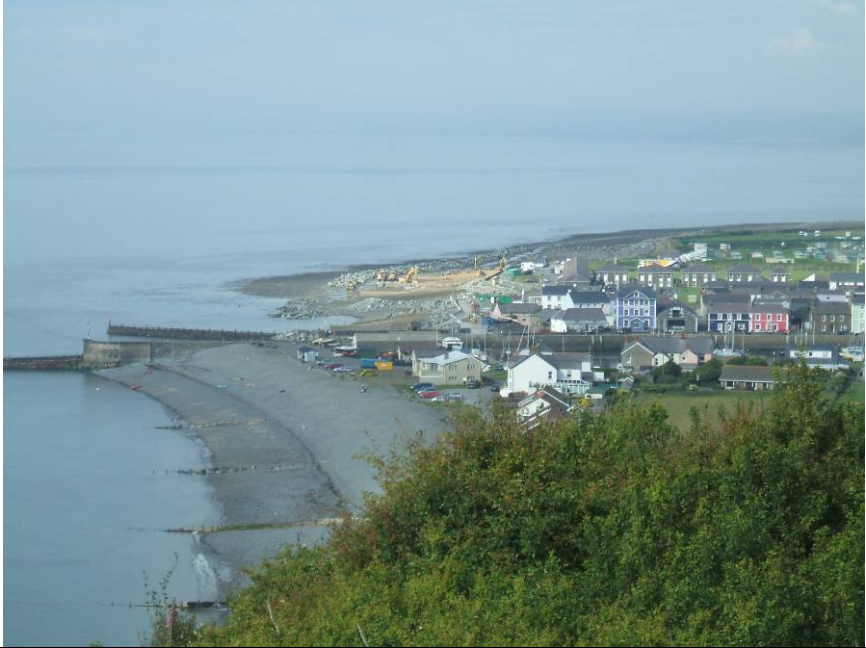
<p>Picture: Aberaeron</p>

<p>Description</p>	<p>This short unit is situated in Cardigan Bay, south of Aberaeron. It faces northwest into the Irish Sea, and extends northeast from the hard rock cliffs of Gilfach-yr-Halen to the harbour of Aberaeron.</p>
<p>Geology and Physical Controls</p>	<p>The hard cliff line provides the main control on the area. South Pier retains material on South Beach Aberaeron.</p> <p>At Gilfach-yr-Halen, high boulder clay cliffs front the underlying bedrock. They are also evident from Cwm Cilfforch up to 400m south west of Pen-y-Gloyn.</p>
<p>Geomorphology</p>	<p>Exposed boulder clay cliffs are found around Gilfach-yr-Halen gives way to hard inerodable sections. The hard cliffs effectively control the rate of erosion of the southern section, but at present do not influence its plan shape strongly. Between Pen-y-Gloyn and the south pier at Aberaeron is a shingle beach stabilised by groynes. Where the clay cliffs have been eroded the foreshore is fairly wide.</p>

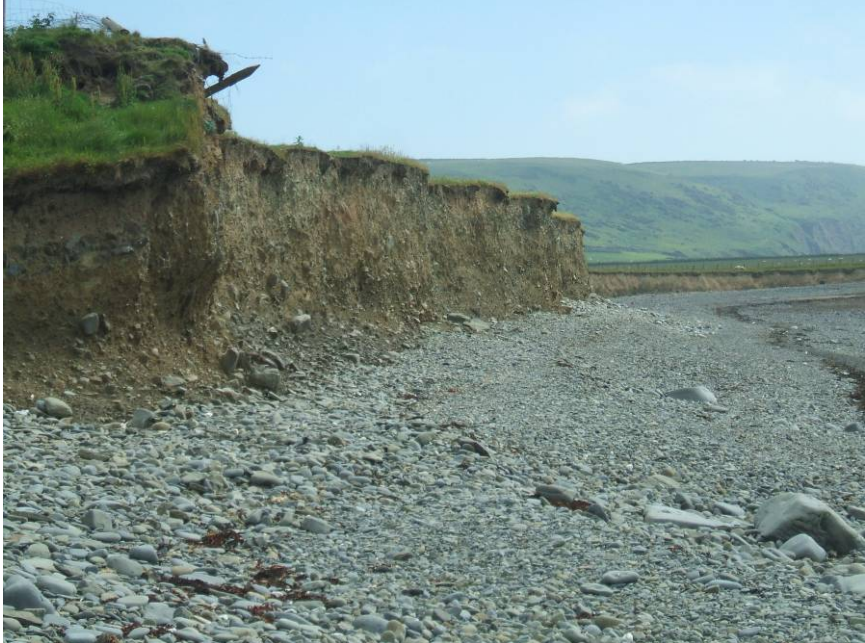
<p>Picture: Aberarth beach</p>

Geomorphology	<p>Most of the section between Aberaeron and Aberarth is fronted by shingle, although south of Aberarth drift is exposed in cliffs up to 5m high.</p> <p>The frontage from Aberarth to Llanrhystud is characterised by steep low backshore gravelly clay cliffs, generally fronted by gravel beaches and wide expanses of well-bedded scree foreshore. The unit between Aberarth and Morfa Mawr includes high vertical rocks. However, north of Aberarth the cliffs are fronted by boulder clay.</p> <p>Around the mouth of the Afon Cledan (and Peris) coarse fluvial gravels have been deposited, becoming thinner and finer to the north and the south. The section provides a rare and excellent exposure through a periglacial alluvial fan, and shows Welsh till, Irish Sea till and several gravel facies.</p> <p>From Llanrhystud, extending for some 2km south of the Afon Wyre, the boulder clay platform is fronted by a shingle beach.</p> <p>The one section of hard cliff (1.5km north of Aberarth) apparently plays little role in influencing the erosional development of the frontage.</p>

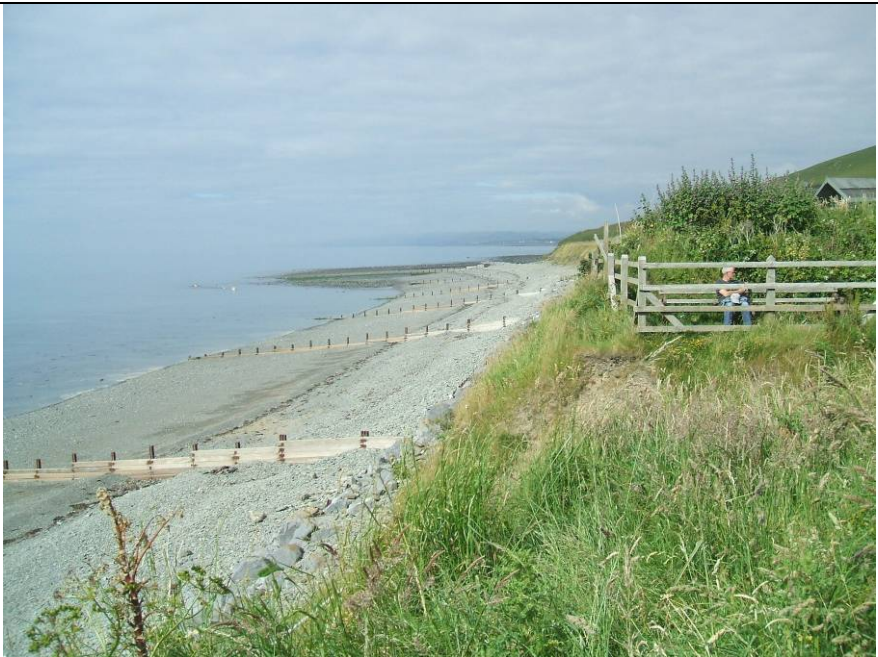
<p>Picture: Morfa Bychan</p>

<p>Description</p>	<p>This unit is situated south of Aberystwyth, in central Cardigan Bay. It is undeveloped, and extends north-northwest for approximately 10 km from the hard rock cliffs at Carreg Ti-pw to Allt Wen.</p>
<p>Geology and Physical Controls</p>	<p>This area of coastline is mainly fronted by rock cliffs of sandstone and mudstone, with areas of boulder clay. Drift-fronted cliffs extend for about a mile south of Morfa Bychan.</p> <p>The cliffs are the main physical control on this frontage. Sarn Gynfelyn Provides some protection from waves approaching from the north.</p>
<p>Geomorphology</p>	<p>This is an erosional cliffed coast, which develops through ongoing downwearing of the shore platform, which exposes the backing cliffs to wave attack and destabilisation. The failure of those cliffs releases sedimentary material, which builds the beach.</p> <p>Most of the cliffs here are hard, and erode slowly. In the centre of the unit are the drift fronted cliffs south of Morfa-Bychan, and these are more vulnerable to erosion.</p>

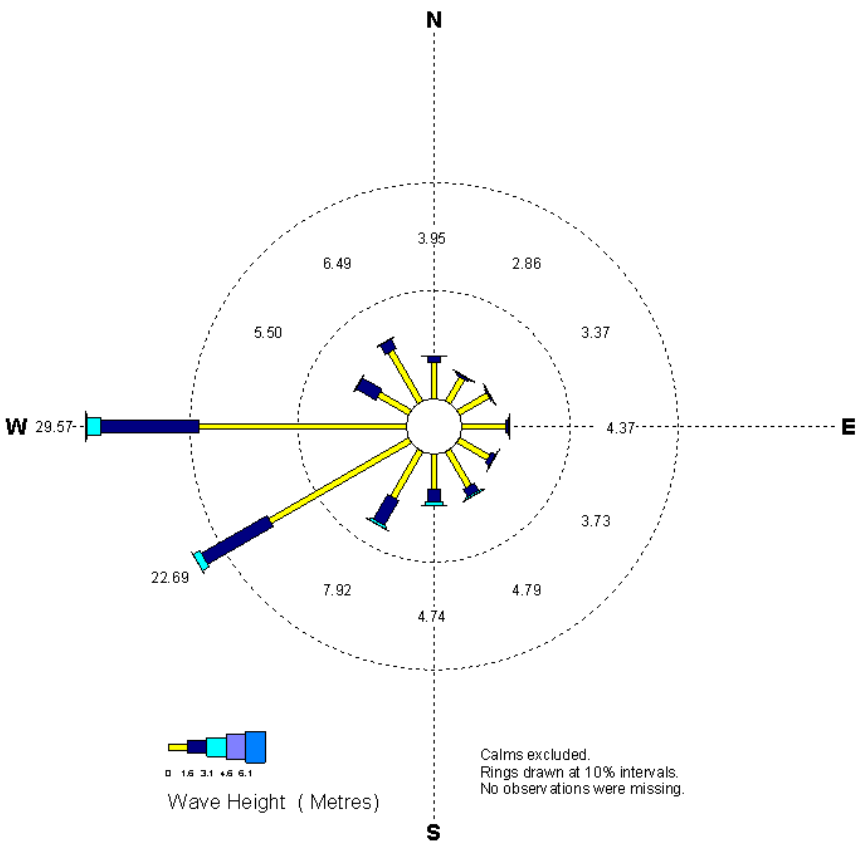
<p>Waves in this region are best described by the wave rose shown above, which is taken from Jacobs Babbie (2006) and was derived from six years of Met Office data for location 52.5°N, 4.5°W.</p>

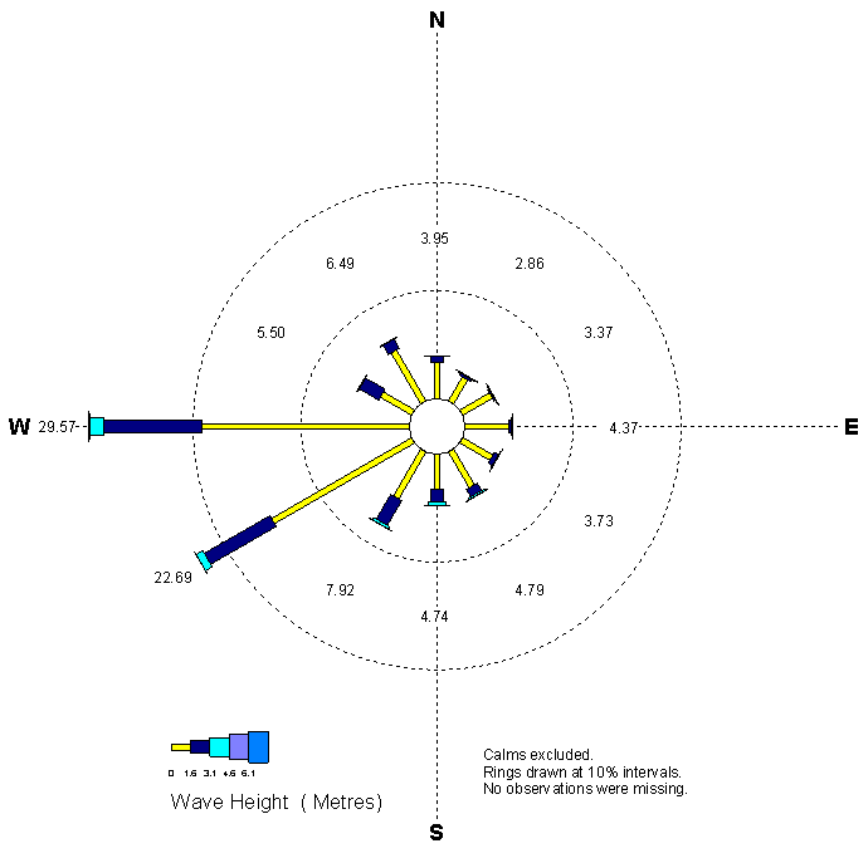
<p>Waves in this region are best described by the wave rose shown above, which is taken from Jacobs Babbie (2006) and was derived from six years of Met Office data for location 52.5°N, 4.5°W. It can be seen that the predominant wave direction is the west and west-southwest. The largest waves, of over six metres, approach from the west.</p>
Erosion and Flood Risks	<p>The original SMP recognises that beach erosion can be high, but variable throughout this unit. The seawalls prevent loss of the seafront. Erosion was not highlighted by the Aberystwyth Coastal Defence Strategy (Jacobs Babbie, 2006).</p> <p>There is relatively low-lying land behind Marine Terrace, which would be liable to flooding in the absence of defences.</p>

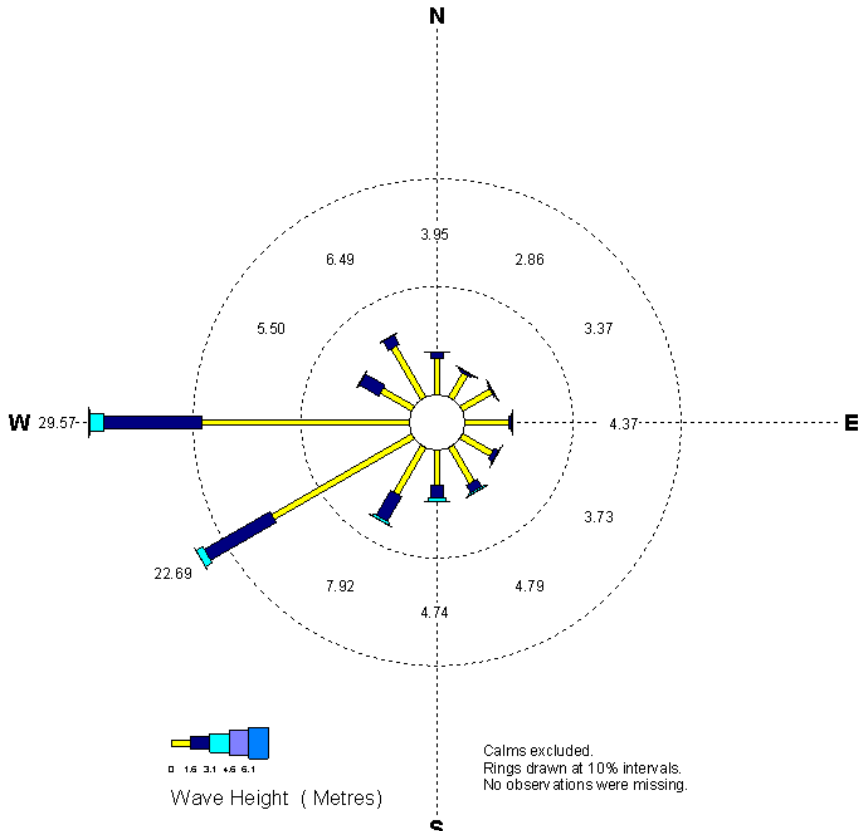
<p>Waves in this region are best described by the wave rose shown above, which is taken from Jacobs Babbie (2006) and was derived from six years of Met Office data for location 52.5°N, 4.5°W. It can be</p>

<p>seen that the predominant wave direction is the west and west-southwest. The largest waves, of over six metres, approach from the west.</p>
Erosion and Flood Risks	<p>The original SMP noted erosion of the cliffs at Clarach and Wallog.</p> <p>There is one area of relatively extensive flood risk at Clarach. Flood vulnerability at present is associated with the river, most frequently when it is blocked.</p>
Sediment Dynamics	<p>There is a general drift to the north over most of the frontage.</p> <p>There is little sediment input from the south, but possibly more significant quantities leave the unit to the north. There is probably a weak feed of coarse material from the cliffs south of Clarach on to Clarach Beach.</p> <p>The weathering of the cliffs provides some beach material, particularly in the north. There may be some limited transfer of material from the nearshore to the beaches.</p> <p>The nearshore area is strongly influenced by the sarn. This feature has caused sediment accumulation and influences the local wave climate. To the south of the sarn, the seabed shelves so gently that the 5m isobath is, in places, over 1km offshore. To the north of the sarn, the 5m isobath approaches the base of the cliffs.</p> <p>Locally within Clarach Bay, there may be some net drift reversal (i.e. towards the south) over the northern end of the bay. Photographic evidence shows variation in material type forming the beach at Clarach; sand has been replaced by shingle in recent years.</p>

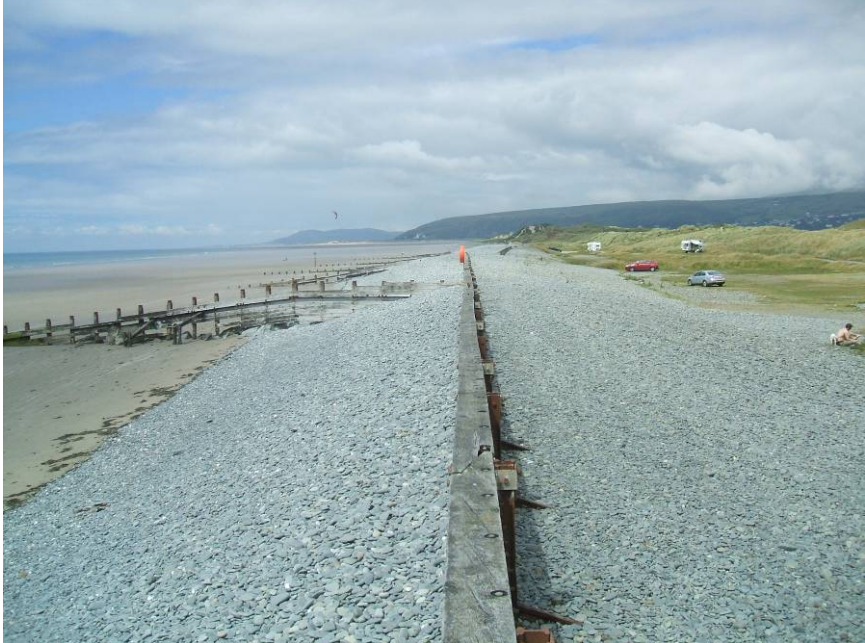
<p>Picture: <i>Ynyslas beach, showing the gravel ridge and defences.</i></p>

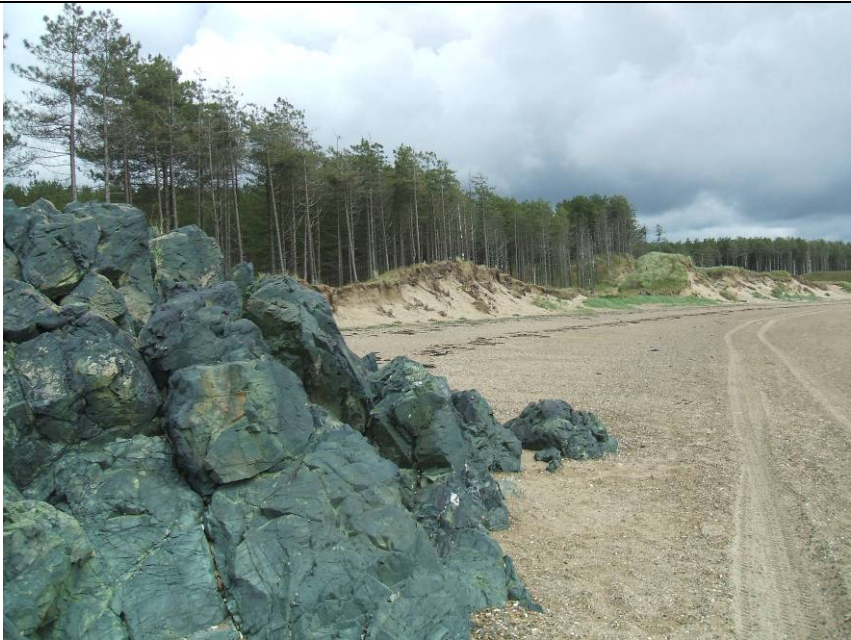
<p><i>Picture: eroded dunes at Newborough Warren, close to Llanddwyn Island</i></p>

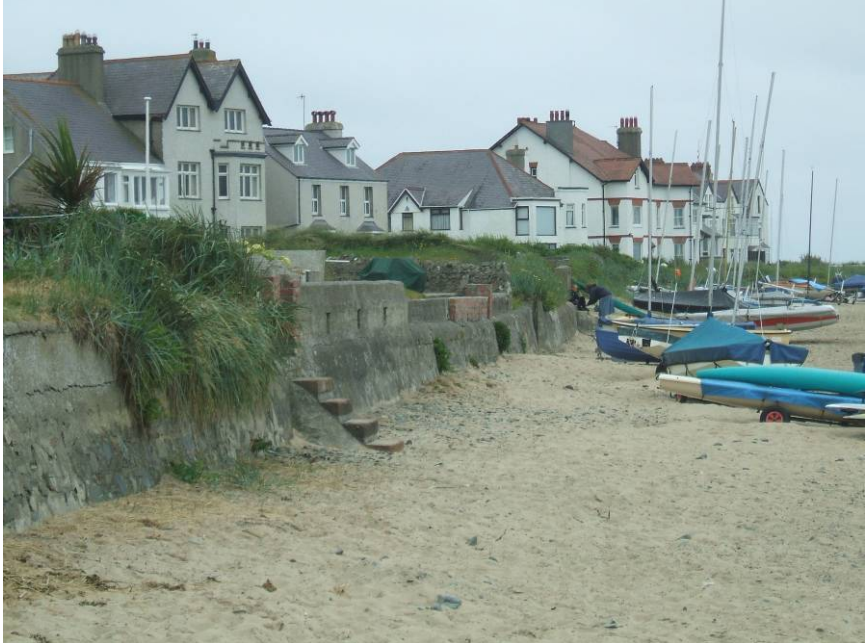
<p>Picture: Defences at Rhosnegir</p>

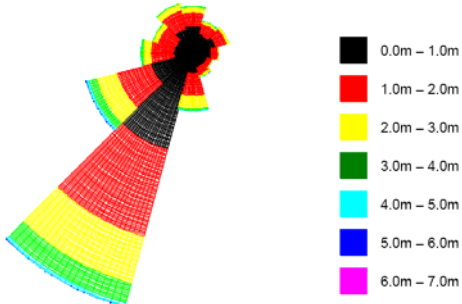
<p>Wave conditions at 53.3°N 4.9°W between June 1991 and January 2004 (Faber Maunsell, 2006)</p> <p>Analysis of the data provided the following extreme wave heights: 1:10 year 6.2 m, 1:50 year 7.0 m, 1:100 year 7.2 m.</p>

<p>Between Porth Nolba and Rhosneigr is a sandy beach with numerous rock outcrops; the backshore is comprised of dunes.</p> <p>To the north of Rhosneigr the sandy foreshore of Traeth Crigyll and Traeth Cymyran extend to the entrance to the straits between Ynys Mon and Holy Island. This part of the frontage is backed by dunes and the division between the two beaches is marked by the rock outcrops of Ynys Feurig, which act to anchor the shoreline.</p>
Wave Climate	<p>Faber Maunsell (2006) derived offshore wave conditions in this area (53.3°N 4.9°W) from Met Office data describing June 1991 to January 2004. This showed a strong predominance of waves from the southwest, as can be seen in the figure below, which is reproduced from that study.</p>

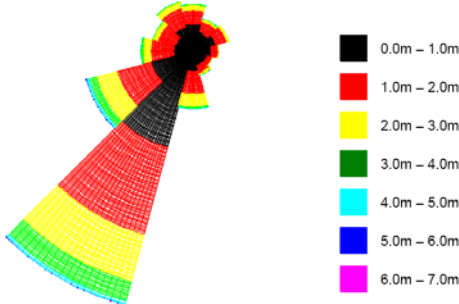
<p>Wave conditions at 53.3°N 4.9°W between June 1991 and January 2004 (Faber Maunsell, 2006)</p> <p>Analysis of the data provided the following extreme wave heights: 1:10 year 6.2 m, 1:50 year 7.0 m, 1:100 year 7.2 m.</p> <p>The Futurecoast database provides inshore wave data at Penrhyn Mawr. Here the dominant wave directions are between 180° and 330°, and wave heights of up to 4.25m are possible between 210° and 270°.</p>

<p>Between Trearddur Bay and Porth-y-Post the rock shoreline is interrupted by a series of small inlets in which coarse sediment beaches have formed. Defences have been built to support the road that passes the head of these inlets.</p> <p>Porth Dafarch is the last of the small bays with the beach being formed predominantly of sand. Defences have been constructed to protect the road and amenities behind the beach</p>
Wave Climate	<p>Faber Maunsell (2006) derived offshore wave conditions in this area (53.3°N 4.9°W) from Met Office data describing June 1991 to January 2004. This showed a strong predominance of waves from the southwest, as can be seen in the figure below, which is reproduced from that study.</p>

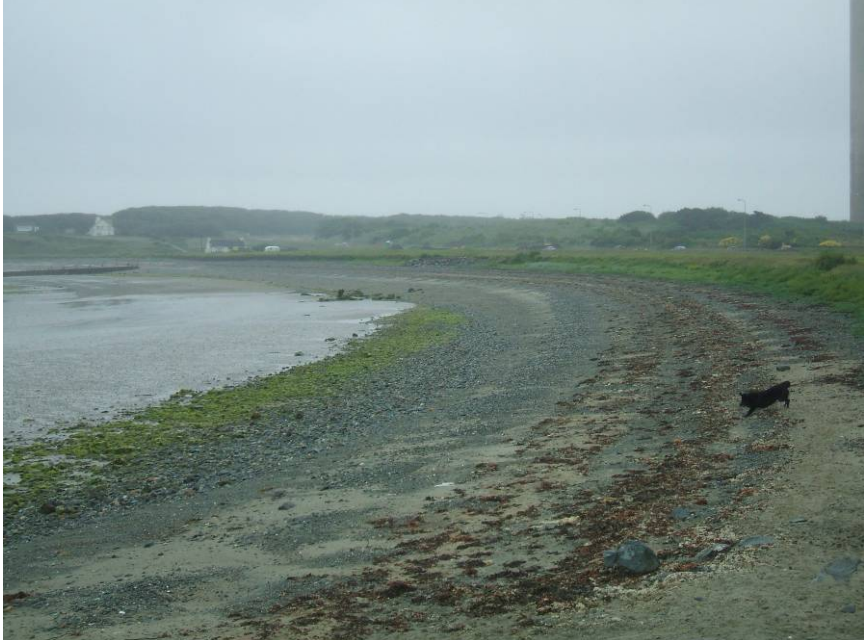
<p>Picture: Penrhos beach</p>

<p>Description</p>	<p>This unit comprises the north eastern shoreline of Ynys Gybi between the Holyhead breakwater and the Afon Alaw. This coast includes the extensive port of Holyhead and its urban frontage, and is therefore heavily engineered. However is also includes part of the relatively natural frontage of the Penrhos Coastal Park.</p> <p>The Alaw estuary, east of Penrhos, is described in the Estuaries Assessment.</p>
<p>Geology and Physical Controls</p>	<p>The bedrock here is Cambrian and metamorphic. At Newlands this is overlain by clay.</p> <p>The major physical controls on this unit are the various port structures, including Holyhead Breakwater, and the rock headlands of Morawelon and Penrhos. The Isle of Anglesey provides shelter towards the north and east.</p>
<p>Geomorphology</p>	<p>To the west the coast is rocky and hard and shows slow ongoing erosion of shore platforms and undermining of steep cliff faces. This produces the characteristic crenulated coastline, where hydrodynamic forces have exploited localised weaknesses in the hard lithology.</p> <p>Traeth Penrhos is sandy bay with a gravel upper beach, which is held between rocky outcrops.</p>

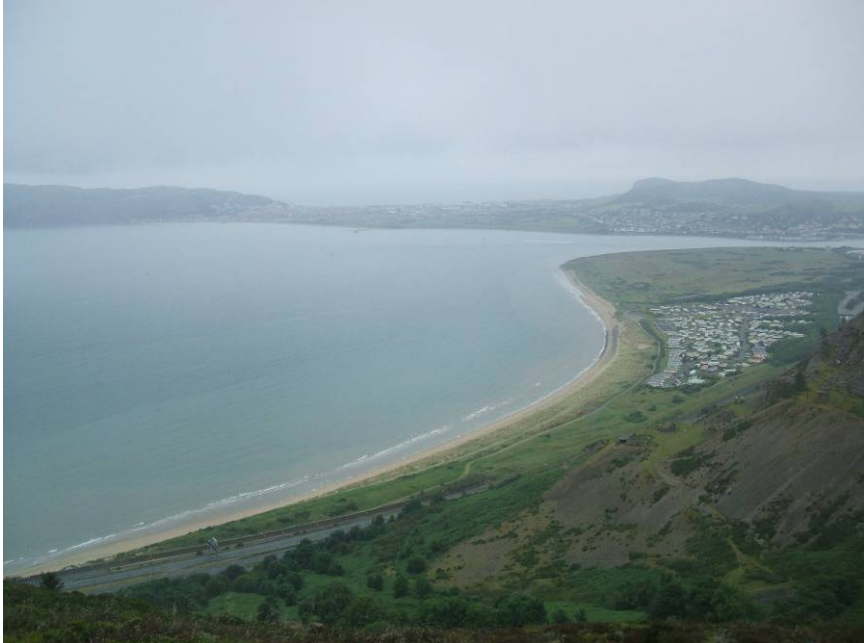
<p>Picture: Conwy Morfa, with Llandudno and the Great Orme</p>

<p>Description</p>	<p>This unit extends northeast from Bangor at the mouth of the Menai Straits to Penmaen-bach Point. The frontage here is fairly developed, and for around half of its length, from Llanfairfechan to Penmaen-bach Point it is backed by a railway and the A55 road. Bangor Harbour is situated close to the western boundary.</p> <p>The Menai Strait and the Conwy estuary are described in the Estuaries Assessment.</p>
<p>Geology and Physical Controls</p>	<p>This frontage is protected by the eastern edge of Anglesey and by Great Orme's Head, to the northeast. Flows through the Menai Strait influence sediment transport.</p> <p>The docks at Porth Penrhyn are the most westerly physical control on the morphology of this unit. The mouth of the Afon Ogwen acts to control sediment movement to the west. Between Llanfairfechan and Penmaen-bach Point the shoreline is controlled by artificial defences apart from the rock outcrops at Pen-y-Clip and Penmaen-bach Point.</p> <p>Most of the underlying geology here is mudstone with igneous intrusions at Llanfairfechan and Penmaen-bach Point. Ash and conglomerates make up the bedrock in the eastern section.</p>

Geomorphology	<p>Between Penrhyn Castle and Llanfairfechan the foreshore is a massive intertidal zone of boulders and loose rocks, which covers nearly the whole area of the north-eastern entrance to the Menai Strait. To the east of Lafan Sands the foreshore is sand and shingle, which also extends into the offshore zone, and almost meets with the Dutchman Bank, an offshore mud and sandbank. Immediately behind the foreshore is a low-lying area several hundred metres in width, beyond which rises gently sloping lowland with steeply rising hinterland about a kilometre from the shore.</p> <p>Between Penmaenmawr and Penmaen Bach Point the frontage comprises a glacial till filled embayment within a steeply sloping hinterland, which forms massive headlands of resistant igneous rock at its extremities, Pen-y-Clip and Penmaen bach. Between these headlands is a soft promontory at Dwygyfylchi. Much of the intermediate coastline comprises simple cliffs composed of weak sandy strata and reaching heights of approximately 25m. A shingle foreshore overlies a flat sand lower foreshore backed by a storm ridge and, at Dwygyfylchi, a clay bank.</p>
